Bank Removal Dunces Arch Inclosure, Hampshire

HLS Ridge & Furrow, Stump and Bank Removal

Measured Survey and Archaeological Watching Brief Report

27 June 2025

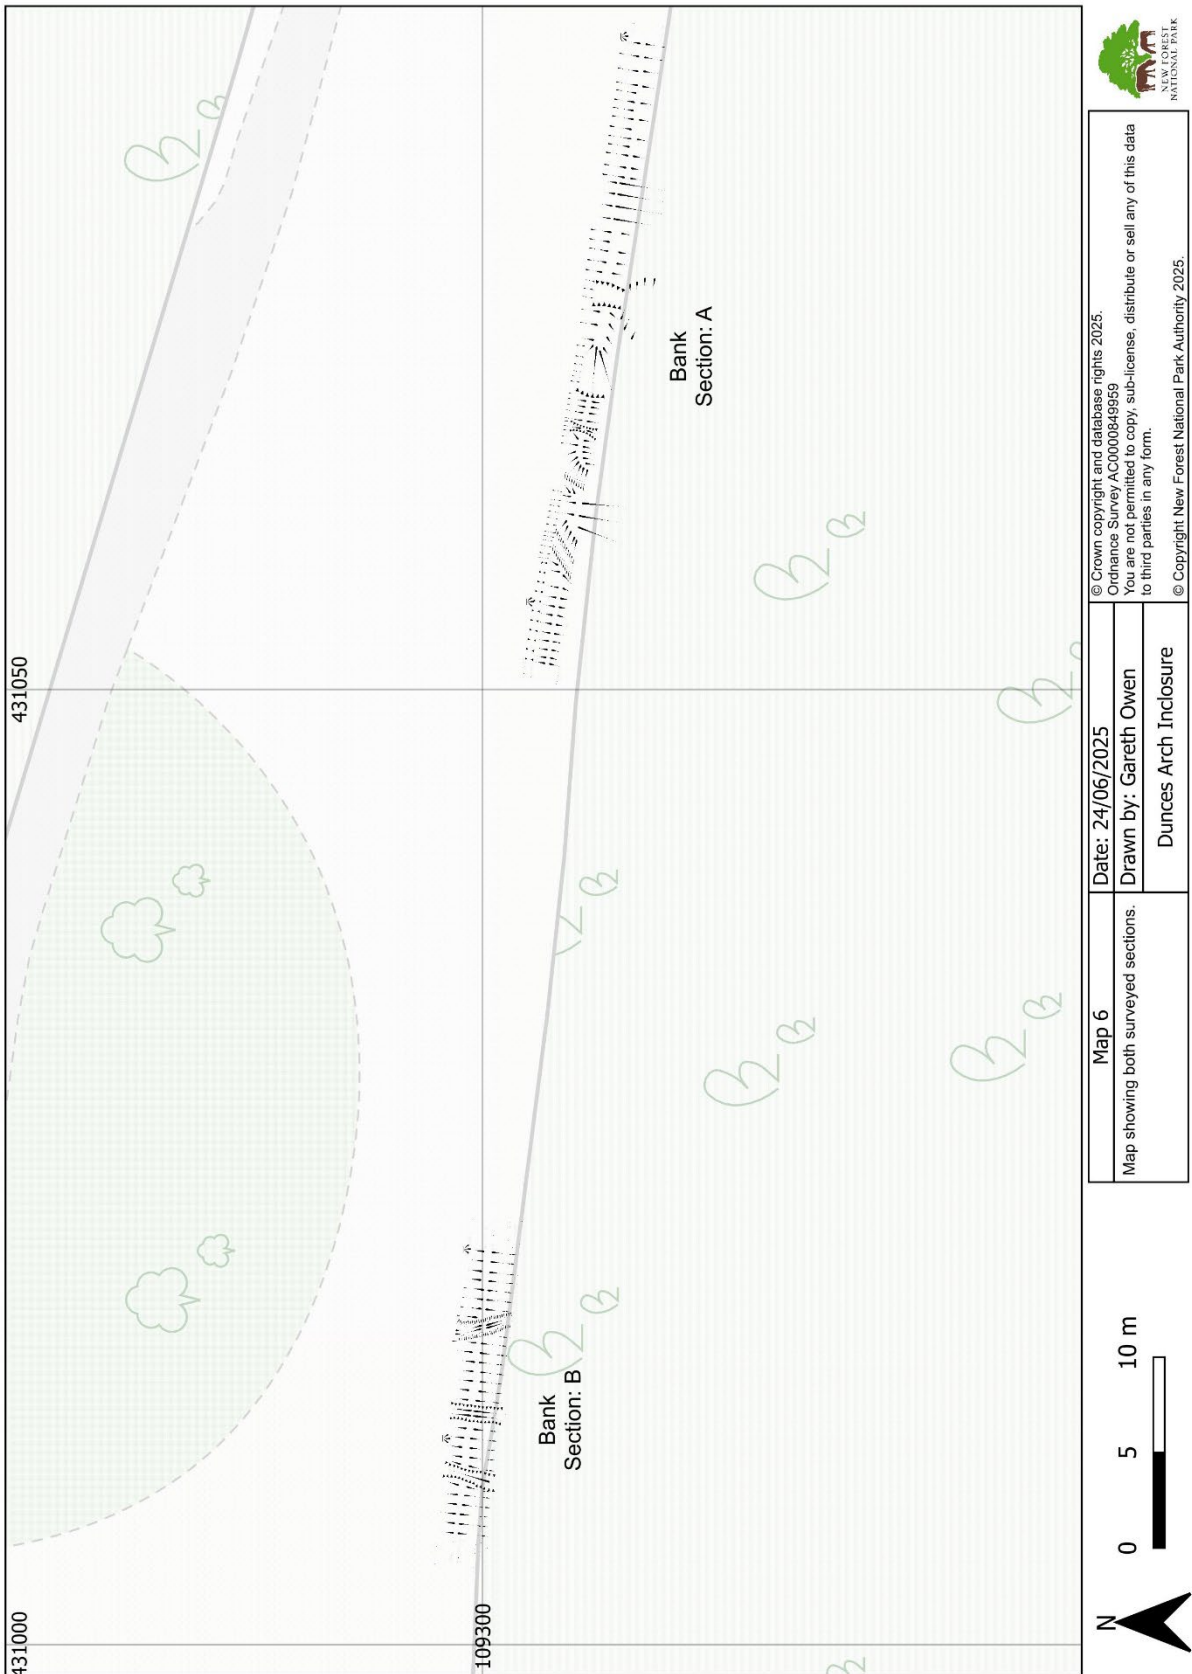
Figure 2: Map showing survey results for both segments of bank (and ditch), prior to removal.

- 3.1 Prior to the groundworks commencing a hand measured survey was conducted of both sections of bank, which had very faint traces of a ditch. The survey was conducted by hand with a total of four Temporary Bench Marks (TBM) being established using a Garmin eTrex GPS and OS Locate App on a smart phone (Fig. 2).

- 4.1 The removed bank and ditch segments were successfully surveyed and recorded prior to their removal (Figs. 2 - 6).
- 4.2 No unknown archaeological features or artefacts were encountered within the monitored groundworks and there were no negative impacts to the barrow.
- 4.3 Despite the scanning of disturbed soils, no finds of archaeological significance were recovered.

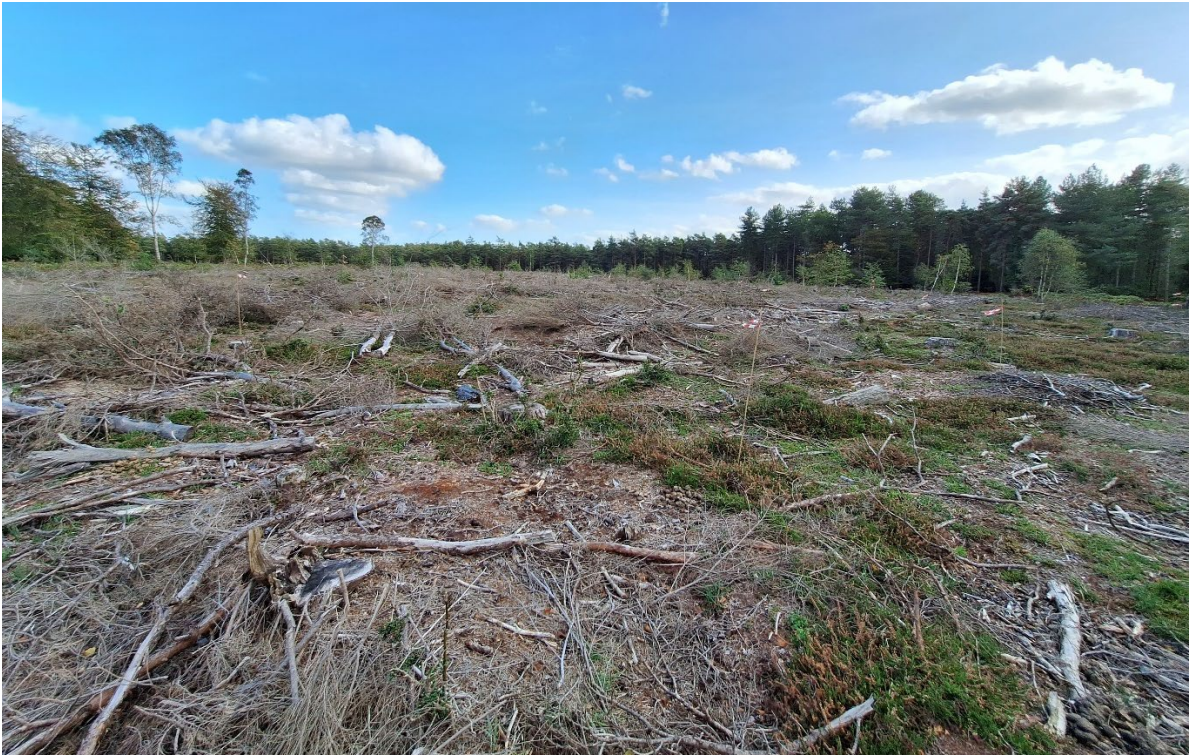
- 3.4 Ridge & furrow, stump and brash removal close to the barrow was undertaken under constant archaeological supervision. Prior to work commencing the area of the barrow had been marked up (bamboo canes and red and white hazard tape) including a buffer area.

Photo 1: Barrow, prior to groundworks. Looking east.

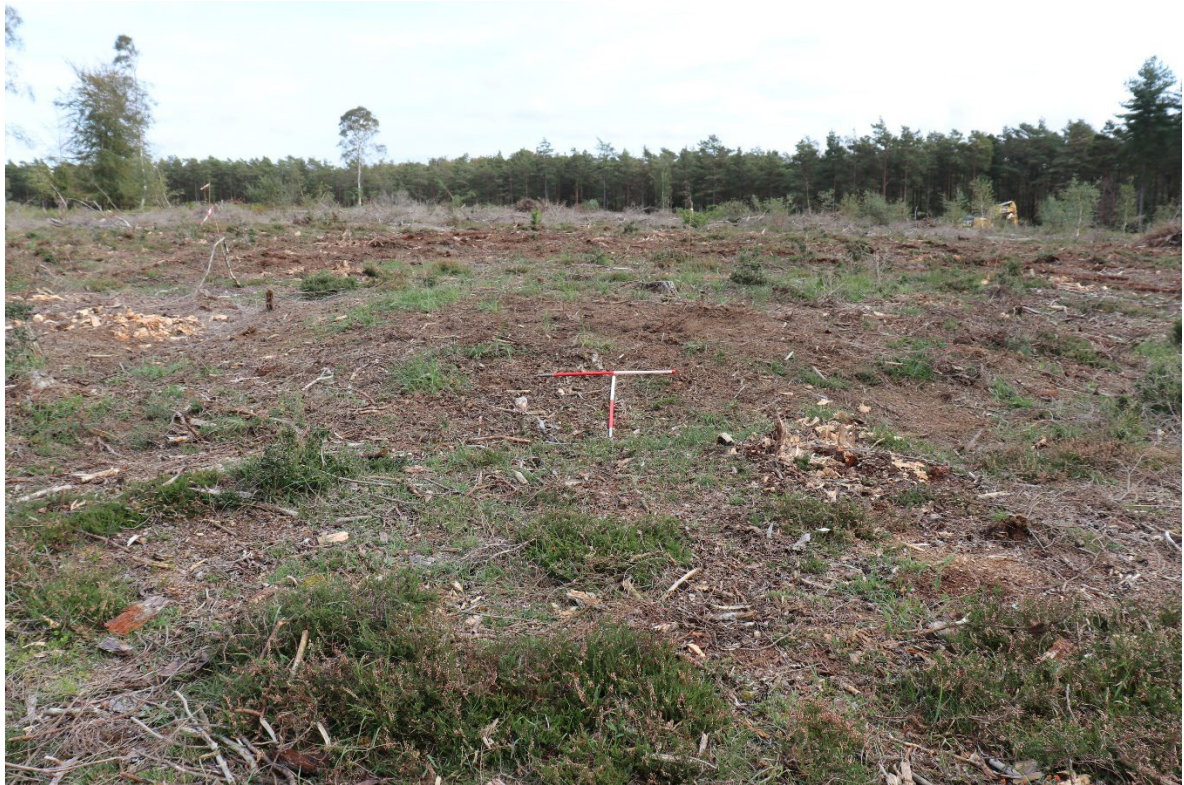
Photo 2: Barrow, post groundworks. Looking east.

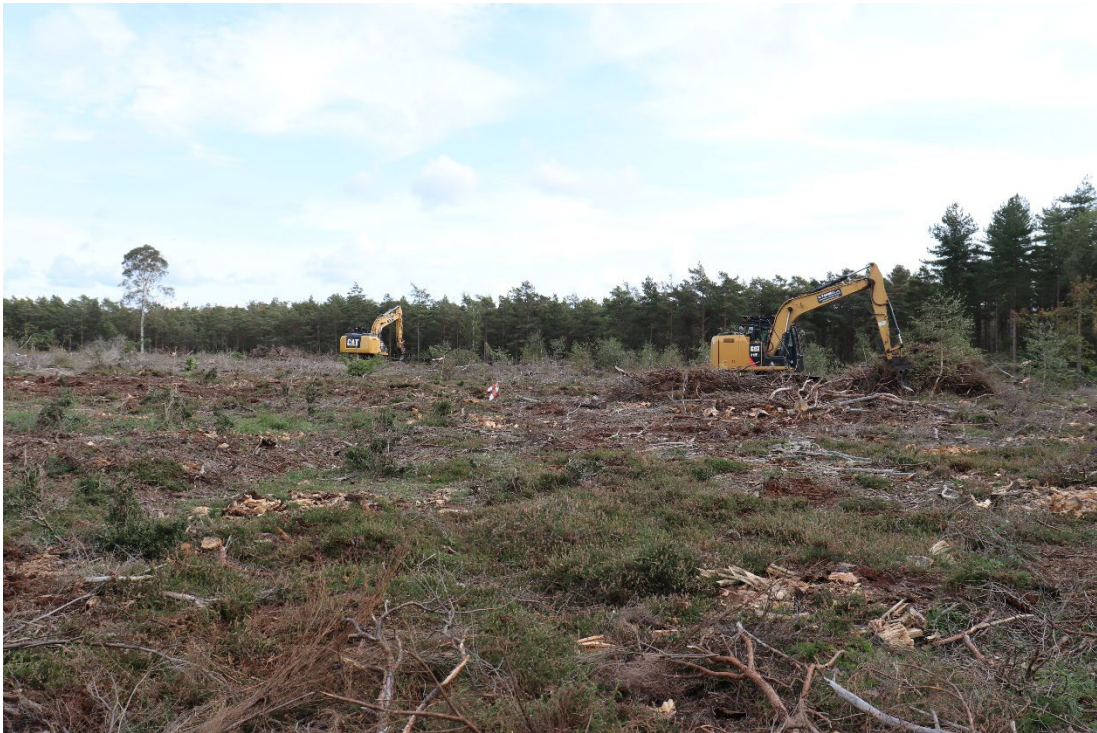
- 3.5 All surface brash was removed by hand. The tracked excavator worked in and from within the buffer area only, reaching into (over) the barrow itself. Ground disturbance was kept to a minimum within the exclusion and buffer zone, (Photos. 1-3).

Photo 3: Working photograph of barrow area. Looking east.

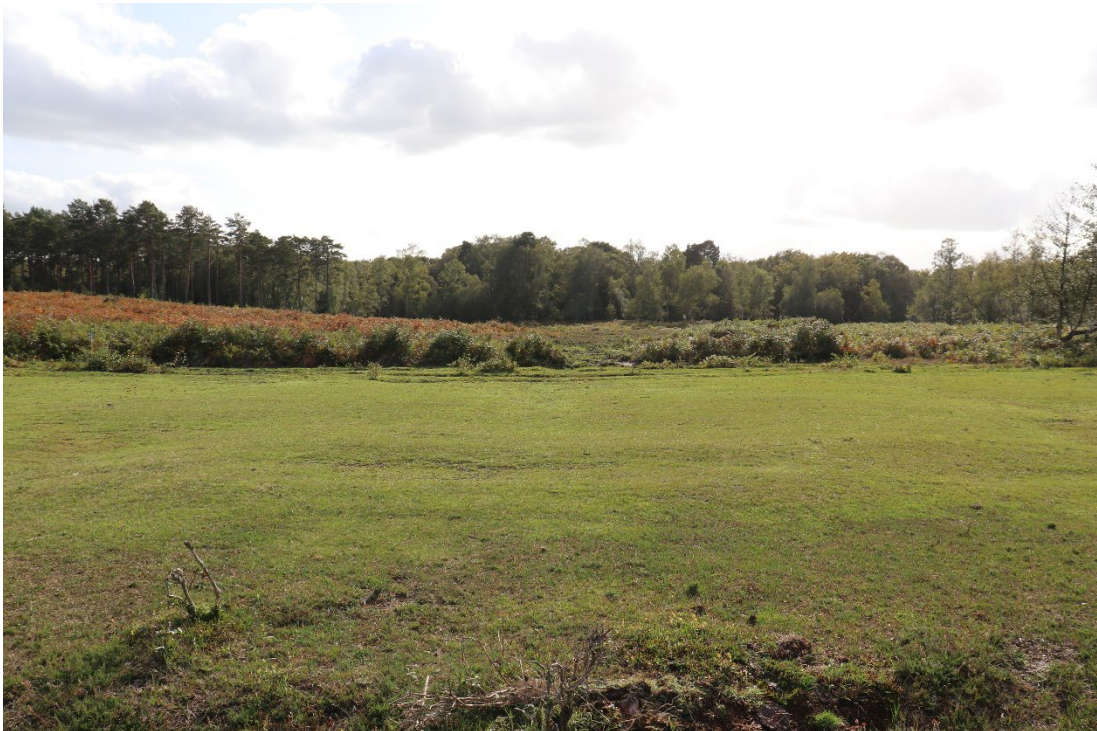
- 3.2 During groundworks a total of 49 metres of bank (and ditch) were removed, segment "A" 34m and segment "B" 15m long, leaving the rest of the bank (and ditch) in place, (Photos. 4 & 5).

Photo 4: Bank segment A. Looking south.

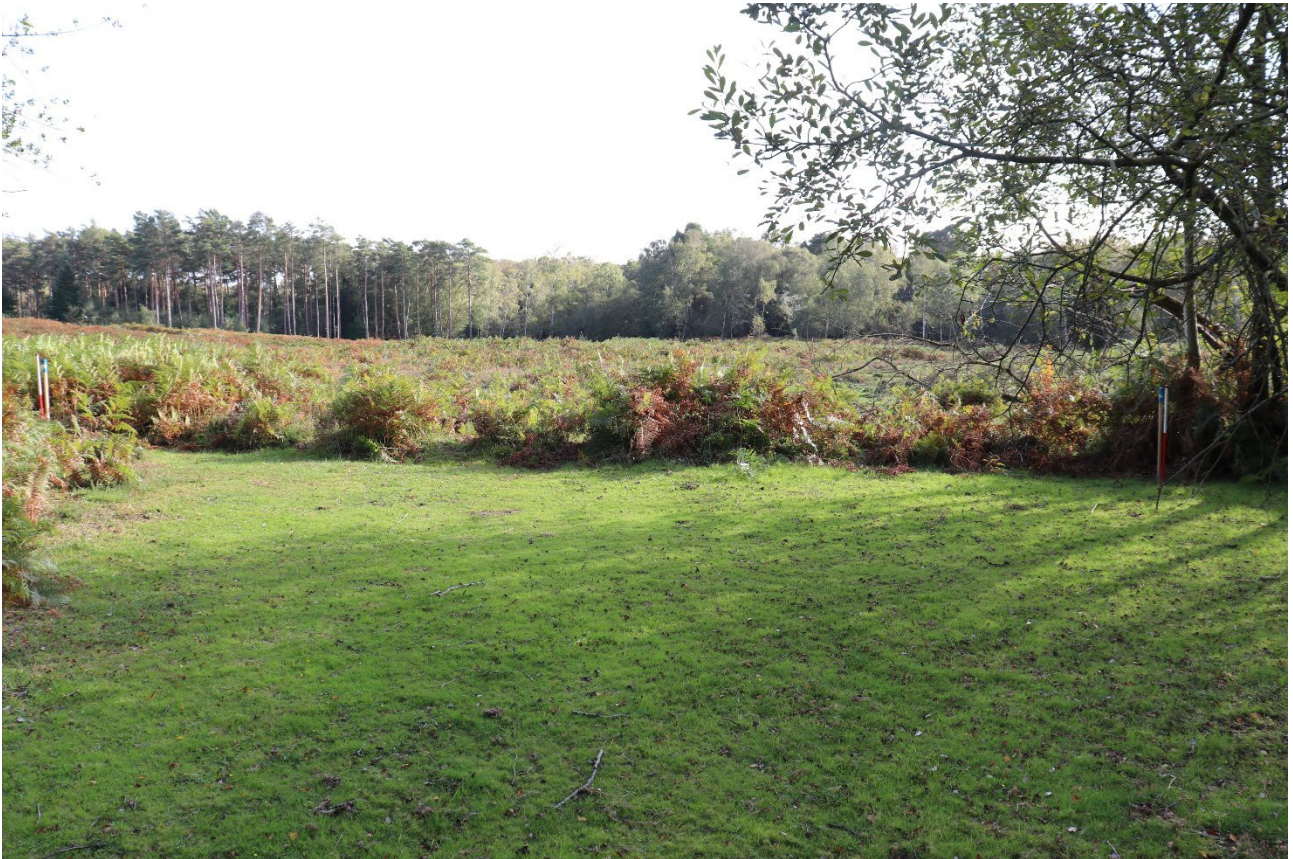
Photo 5: Bank segment B. Looking south.
