## **Hawkhill Mire, Furzey Lodge, Beaulieu Channel Restoration**

### **Archaeological Watching Brief Statement**

Prepared by the New Forest National Park Authority on behalf of the Verderers of  
the New Forest Higher Level Stewardship Scheme

July 2025

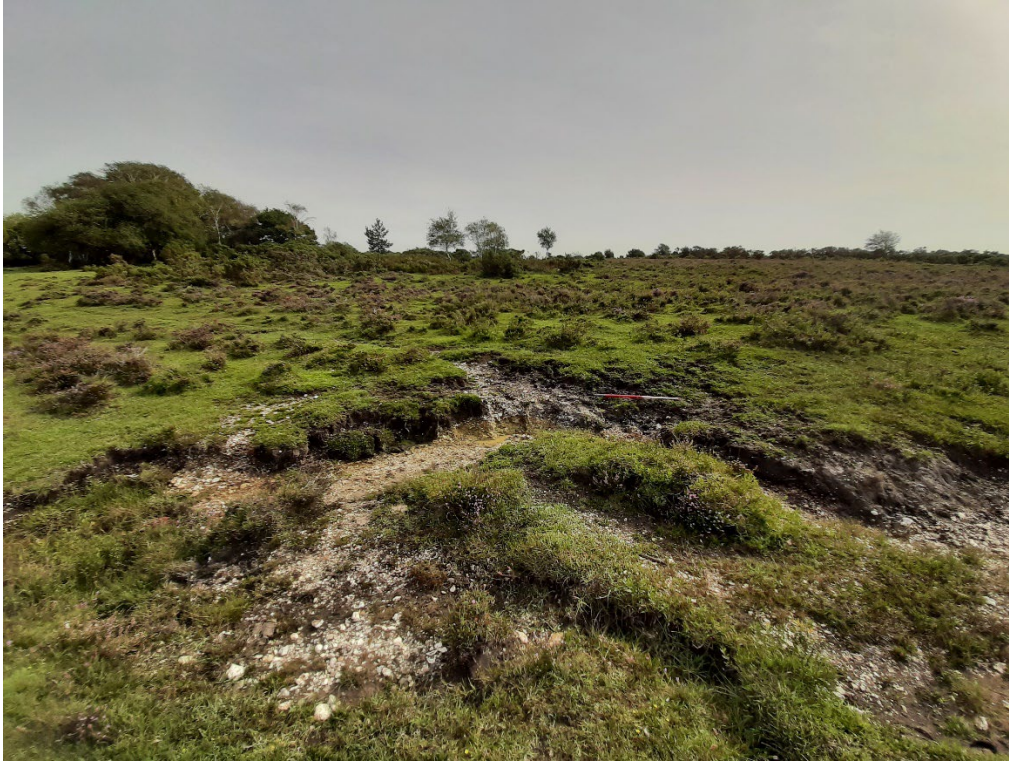
A possible Boiling Site (97/13) had been recorded by the New Forest History and Archaeology group in 2015, though the details had not been submitted to the Hampshire HER. A walk over survey, prior to work commencing, confirmed the feature to be in close vicinity to the proposed groundworks through the discovery of a concentration of burnt stone and a thick layer of charcoal-rich soil in the sides of the eroded channel, Photos. 1 & 2. It was determined that all groundwork should be monitored by a qualified archaeologist to record any archaeological features or artefacts encountered.

Photo 1: Boiling Site (NFHAG 97/13). Looking south. (1m scale).

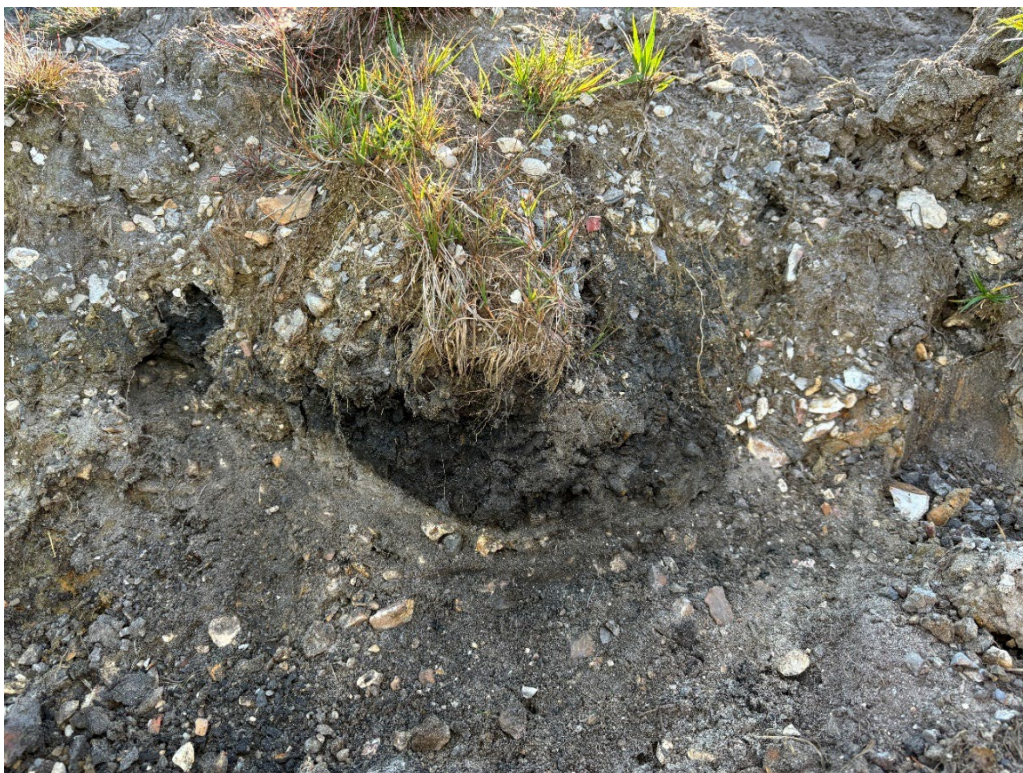
No damage was done to the visible sections of the Boiling Site. Other than the already exposed layer of charcoal rich soil and burnt flint, no previously unknown features or artefacts of archaeological significance were encountered during the works.

Photo 2: Charcoal-rich layer and burnt stone scatter visible in section.

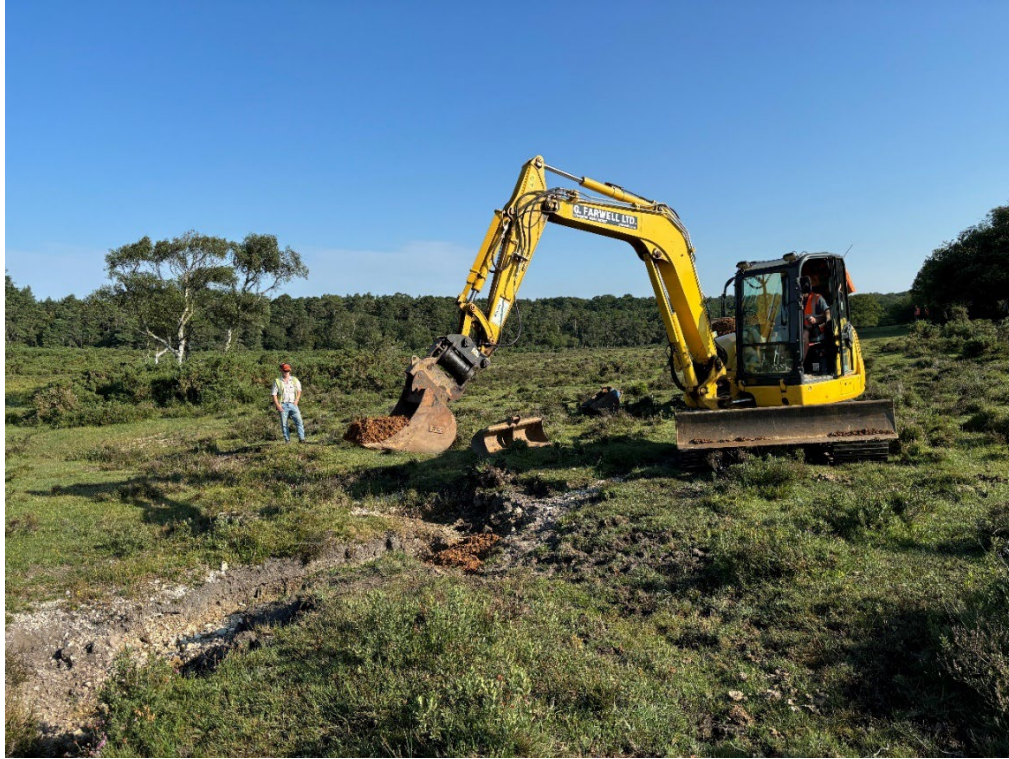
The groundworks consisted of the placing of clay plugs in the channel to stop further waterflow along the channel, along with the deposition of gravel to level the ground surface using an excavator. All plugging and levelling works were monitored. Working photographs can be seen in Photos. 3-5.

Photo 3: Working shot of gravel deposition.

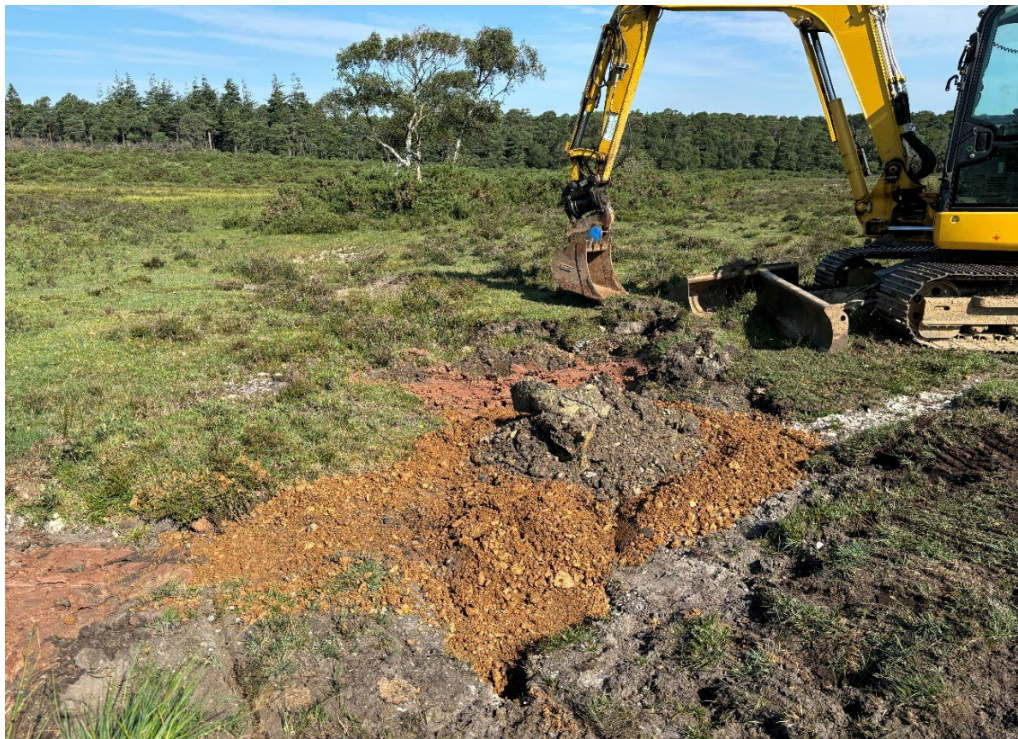
Photo 4: Working shot of gravel deposition.

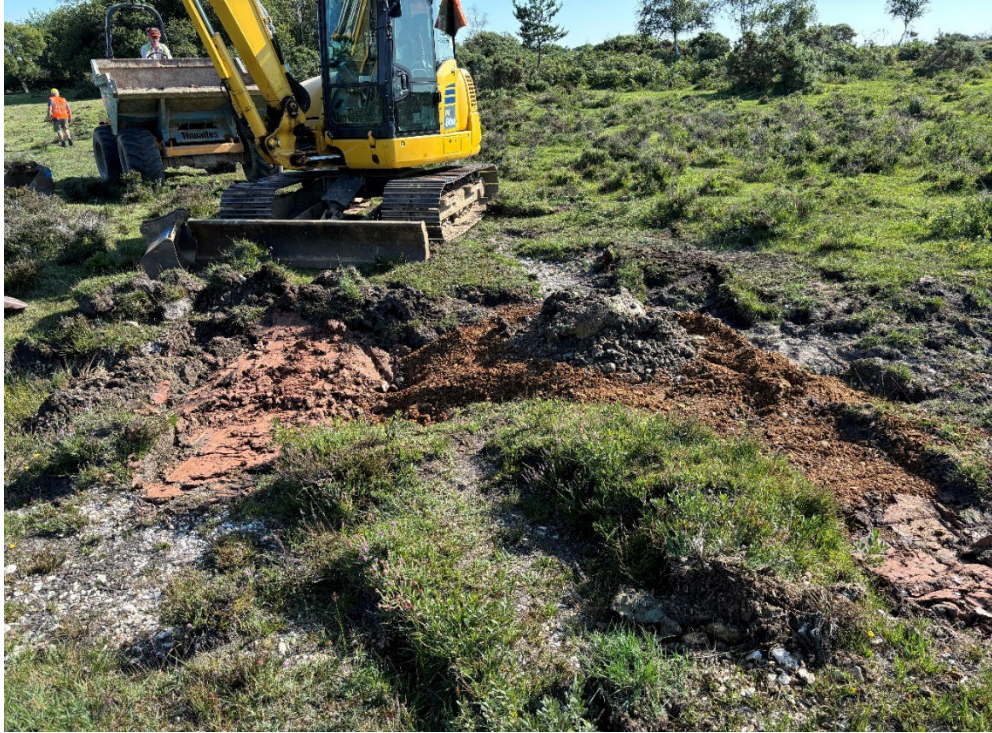
Photo 5: Working shot post gravel deposition before levelling and turf replacement.
